# Assessment and Analysis of the Plaster Exhibit Hall Ceiling at the Wagner Free Institute of Science, Philadelphia, PA

Marlene Lauren Goeke  
*University of Pennsylvania*

A thesis in Historic Preservation Presented to the Faculties of the University of Pennsylvania in Partial Fulfillment of the Requirements of the Degree of Master of Science in Historic Preservation 2008.

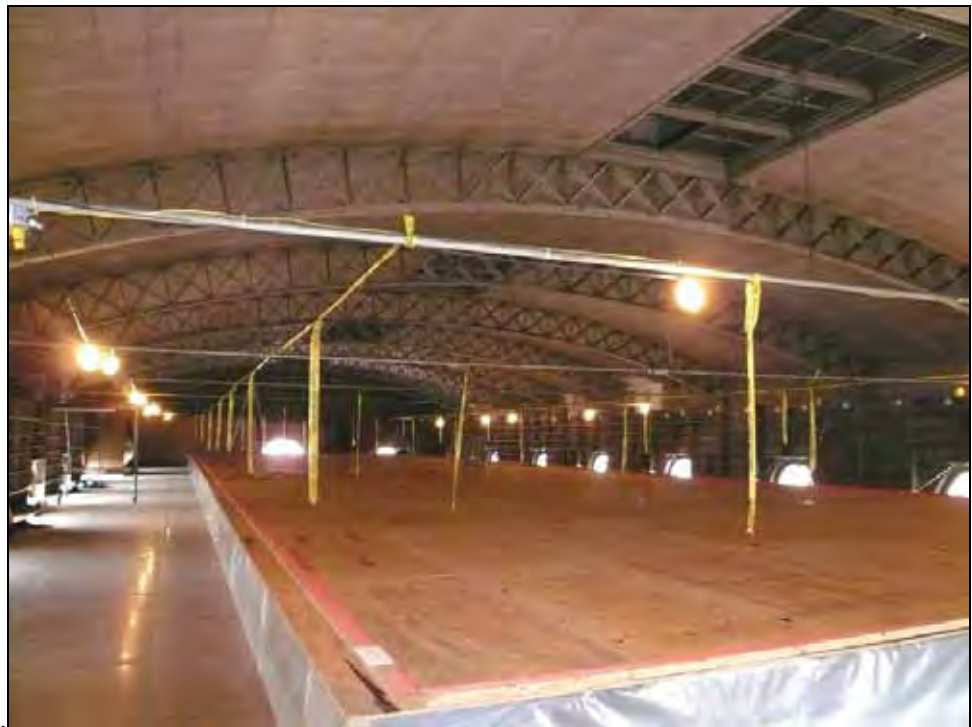
Figure 4: Exhibit Hall with temporary decking. Photo by M. Goeke, 2008

The Exhibit Hall is the largest room in the building, spanning about 60 feet wide and 150 feet long, and rising two stories to the roof. The plaster ceiling is part of the larger system of the Wagner's roof. The barrel vault ceiling is divided into nine bays by eight arched trusses (Figure 4). The trusses are constructed of

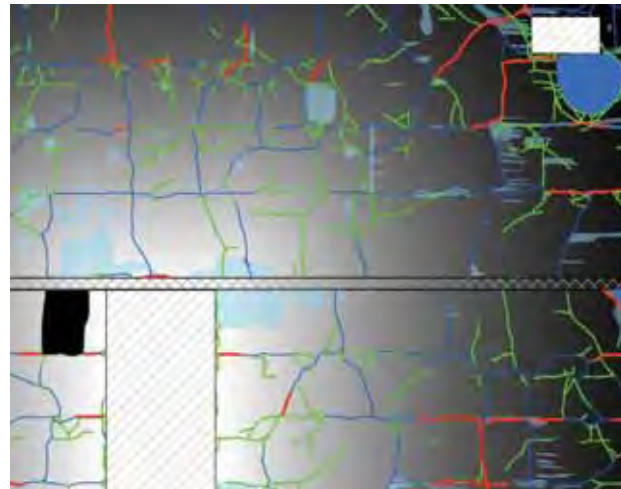
**Figure 5: Distance from skylight. Black and white raster is overlaid with vector conditions in color.**

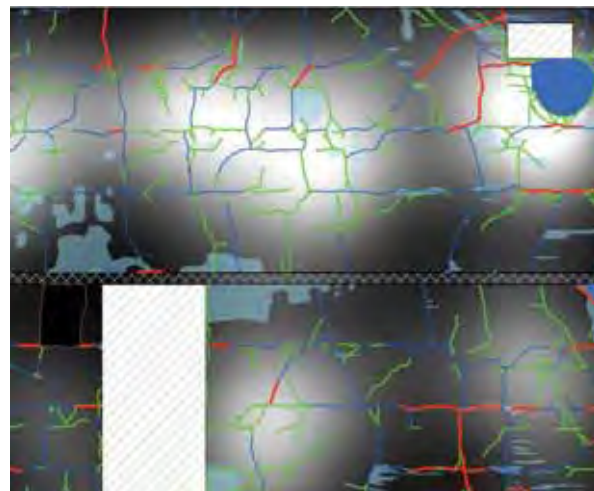
**Figure 6: Density of small cracks with vector overlay.**

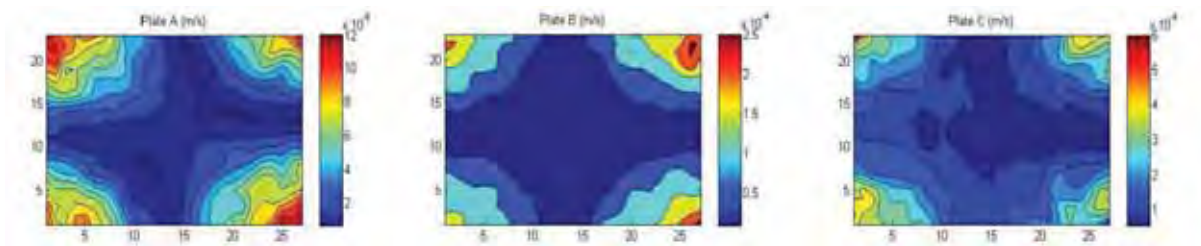
When the results for the three plaster samples are compared, it can be seen that the FRF's are very similar in frequency, and many of the beam and plate modes were observed in the FRF's (See Figures 7A-7C in Appendix A). Between the range of 48 Hz and 54 Hz, the (1, 1) mode could be seen in every sample, and was easily distinguishable. This mode was measured at 53.8 Hz for Sample A, 51.3 Hz for Sample B, and 48.8 Hz for Sample C. The velocity magnitudes for every point on each sample were plotted in MATLAB® for the corresponding modal frequency, as shown in Figure 3. Using MATLAB®, Samples B and

Figure 3: Velocity Distributions at Analyzed Mode: Sample A – 51.3 Hz, Sample B – 51.8 Hz, Sample C – 48.8 Hz (Speaker Excitation 20-500Hz)

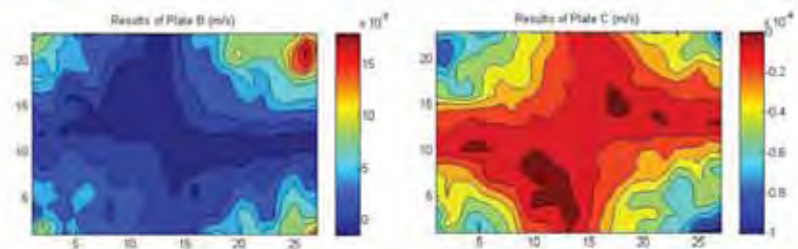
C were then compared to Sample A. A MATLAB® code was used to subtract the velocity magnitudes for Sample A from Samples B and C. The results for Sample B-A and Sample C-A were plotted and are shown in Figure 4. As observed in Figure 4, there is no indication

Figure 4: Comparisons of Sample B & C to Sample A (Speaker Excitation 20-500Hz)

of any types of horizontal faults in either Sample B or Sample C. The data is inconclusive as to the presence of the faults and where the faults are located. Due to the fact that the data is inconclusive, the experiment was performed again over a broader range of frequencies using an F3 piezoelectric shaker driven by band-limited white noise from 20 Hz – 5 KHz. When the results for the three plaster samples are compared from the shaker test, it is once again evident that the FRF's are very similar in frequency. Many of the beam and plate modes can again be seen in the FRF's (See Figures 8A-8C in Appendix A). Between the

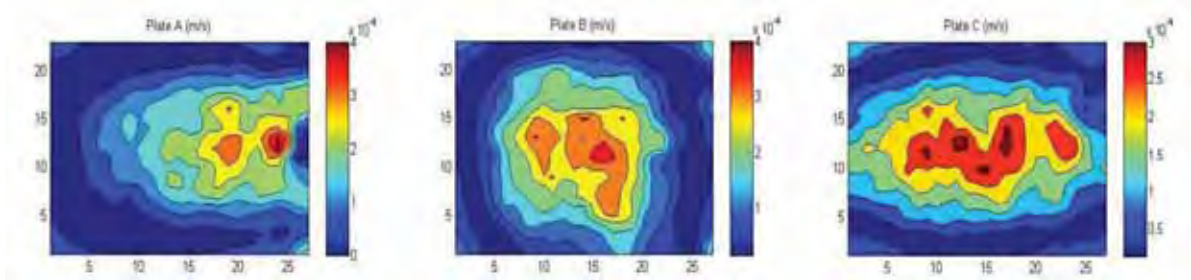
range of 128 Hz and 134 Hz, the same mode was observed in every sample, and was easily distinguishable from any other mode. This mode was measured at 131.3 Hz for Sample A, 133.6 Hz for Sample B, and 128.1 Hz for Sample C. The velocity magnitudes for every point on each sample were then plotted for the corresponding modal frequency, as shown in Figure 5.

Figure 5: Velocity Distributions at Analyzed Mode: Sample A – 131.3 Hz, Sample B – 133.6 Hz, Sample C – 128.1 Hz (Shaker Excitation 20 Hz – 5 KHz)

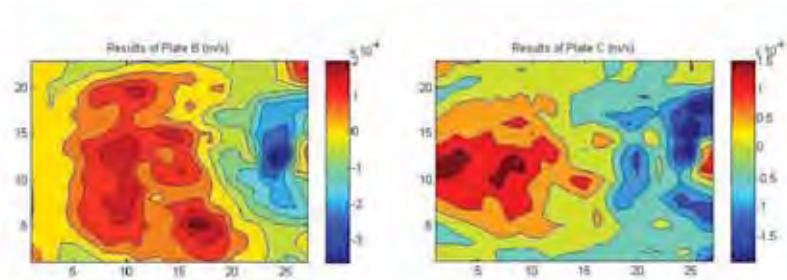
Figure 6: Comparisons of Sample B & C to Sample A (Shaker Excitation 20 Hz – 5 KHz)

The results from Figure 6 again show that there is no indication of any types of horizontal faults in either Sample B or Sample C. Thus, the data is again inconclusive as to what types of faults are present and where the faults are located.

1. Use a different excitation source to generate a response at higher frequencies.
2. Develop a method that can compare the local properties of a sample to its own global properties.
3. Obtain a larger sample base with the same and combined faults, in order to determine the repeatability between the samples.
